# Corrosion of Heat Exchanger Materials under Heat Transfer Conditions

R.L. Tapping, P.A. Lavoie, and D.J. Disney  
System Chemistry and Materials Branch  
Chalk River Nuclear Laboratories  
Chalk River, Ontario

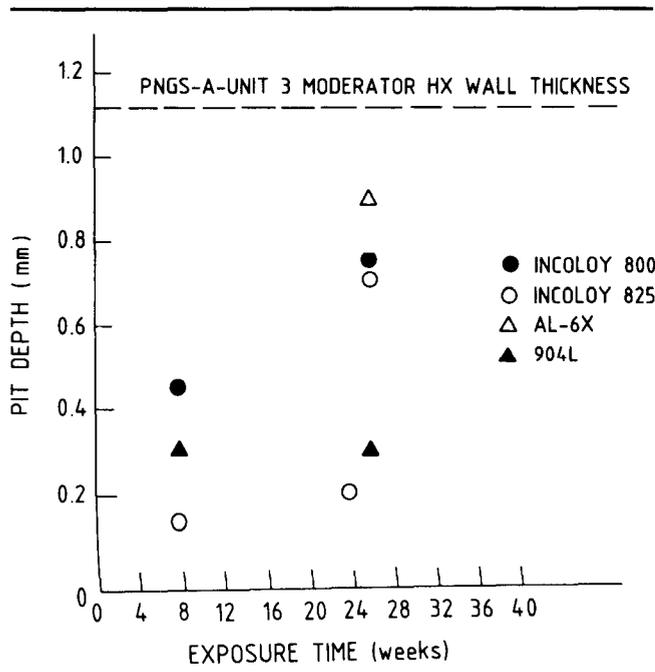
these materials. The results in Table 3 represent an average, at each temperature, of several tests. In the case of I-800, I-825, and Sanicro-28, four or five tests were carried out, particularly at the longer exposure times. The statistical distribution of the pitting was such that results ranged from no pitting to severe pitting on materials such as I-825, and I-800 always suffered some pitting; Sanicro-28 never did show any evidence of pitting attack. Figure 2 presents the pitting data in terms of pit depth as a function of time.

**Figure 2:** Average maximum pit depths for moderator heat exchanger tube materials subjected to laboratory testing in Lake Ontario water.

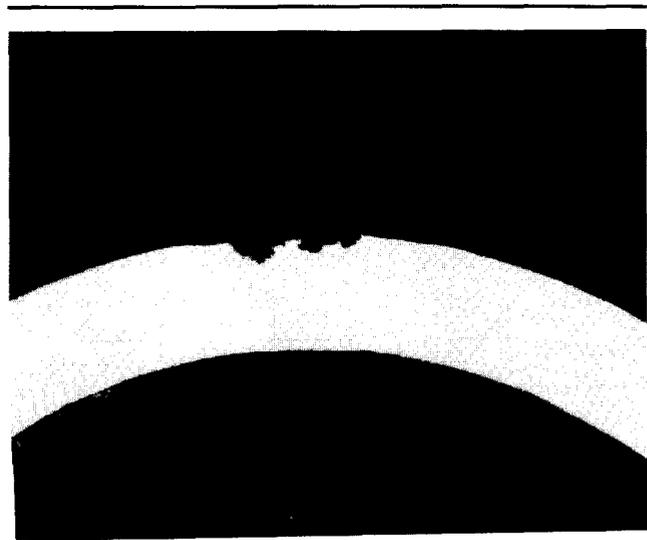
As shown in Table 3, I-800 is quite susceptible to pitting, I-825 somewhat less so but still susceptible, and AL-6X and type 904L stainless steel subject to occasional deep pitting. Figures 3 to 6 show some maximum depth pits for I-800, I-825, AL-6X, and type 904L stainless steel. The pit shapes are characteristic of under-deposit chloride attack. Sanicro-30 was less sus-

**Figure 3:** Typical deep pit in Incoloy 800 after two months' exposure to Lake Ontario water (with a crevice).

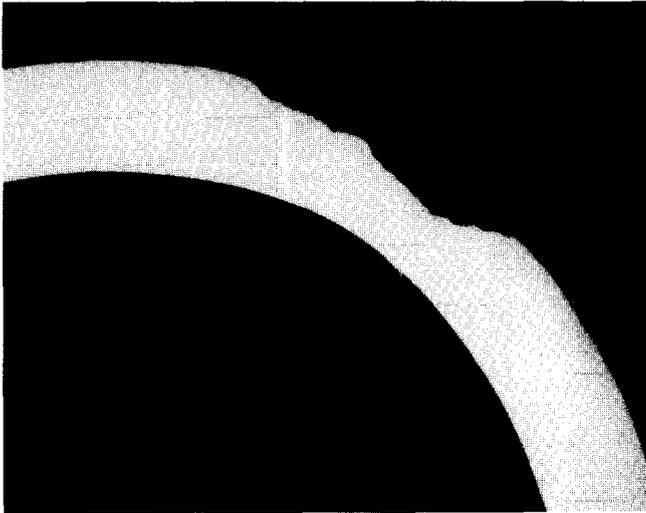
**Figure 4:** Typical deep pit in Incoloy 825 after 26 weeks' exposure to Lake Ontario water (with a crevice).

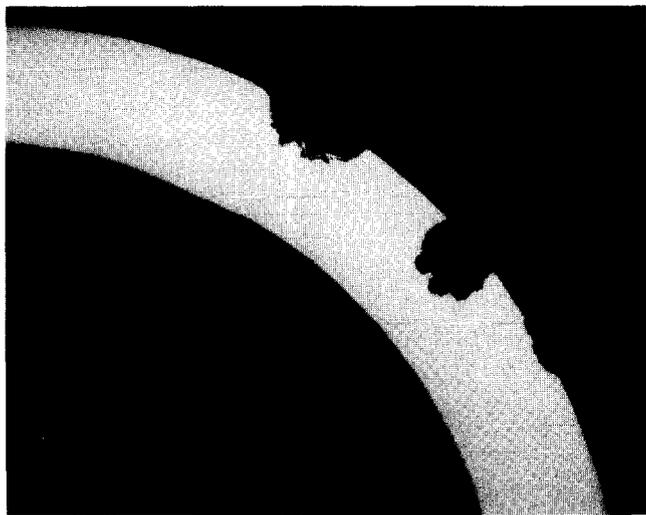
**Figure 5:** Typical deep pits found on AL-6X sample after 26 weeks' exposure to Lake Ontario water (with a crevice).

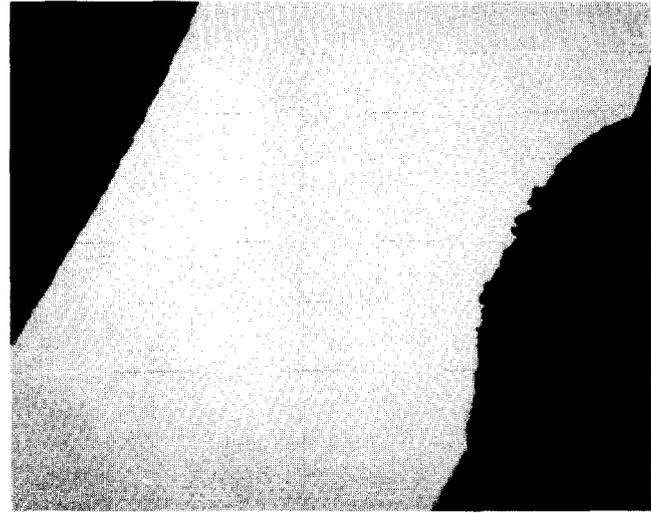
**Figure 6:** Pit noted on 904L sample after 26 weeks' exposure to Lake Ontario water (with a crevice).
