619
The Technology of Nuclear
Reactor Safety, Vol 1
Table 3-2
MIT Press
Thompson
& Associates

3.3 The NRX Reactor Accident [15, 16a, 16b, 17, 18]

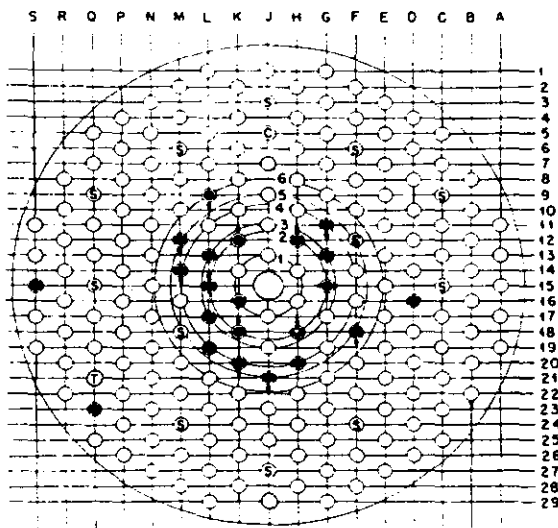
FIG. 3-1 Damaged elements in the NRX core. The plan of the lattice shows rods with abnormal cooling arrangements (indicated by small arrows, \uparrow = temporary cooling upflow, \downarrow = temporary cooling downflow); the rod at G-15 is air-cooled. The open circles indicate those rods not ruptured. The black circles with a white annulus (L-9, K-12, G-15, K-16, K-18) are the fresh rods whose outer sheaths were ruptured; similar circles with segmented annulus (e.g., G-11, H-12, M-12) are irradiated rods whose outer sheaths were ruptured. An encircled S, C, and T indicates the position of a shut-off rod, control rod, and thorium rod, respectively.

dicating those elements which ruptured as a result of the accident. At the time of the accident, only one rod (G-15) was air-cooled as mentioned earlier. The only rod which failed in Circle 1 was a fresh rod in K-16. (The parts of a typical fuel-tube system are shown in Fig. 3-2 [16a].) This rod had a small hole in the outer sheath and the calandria tube had a much larger hole. It is surmised that the heat from the very severe rupture of L-15 may have helped to cause the breakdown of K-16. In several instances failure of fuel in one pressure tube caused damage in an adjacent pressure tube. The six rods in Circle 2 were a part of the test being conducted and all were being fed with an upward stream of cooling water with a lower head than usual. As a result, these elements evidently voided first, causing additional local flux increases (in a sense, a local reactivity effect) and causing melting in these elements to be most severe. Other elements with temporary cooling melted shortly thereafter. Damage to some of the normally cooled rods in Circles 3 and 4 appears to indicate that the light water in a number of rods inside Circle 5 was boiling and being expelled by steam. Because of the fuel resistance to the escape of water, the steam pressure built up within the cooling section and at least two rods, M-14 and K-20, broke apart and the upper portions of their shielded sections leaped a foot or so into the air. The air-cooled rod, G-15, which is in Circle 2, the circle of maximum flux, did not damage the calandria tube so far as could be seen. The central parts of the aluminum sheaths melted and ran down the rod, congealing between the calandria tube and the rod. This aluminum formed a barrier on top of which molten uranium formed an

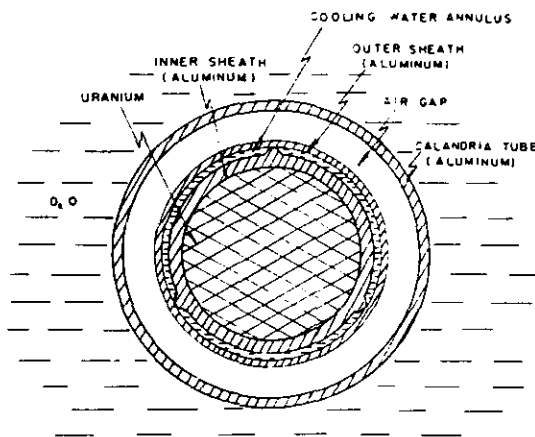
FIG. 3-2 NRX fuel tube cross section. Outer diameter of calandria tube is 2-3/8 in. (6.03 cm).

ingot contained by the calandria tube. At this point, heat transfer between the calandria tube and heavy water apparently preserved the tube itself. Since there was no damage to the calandria tube in this case, it is evident that steam considerably influenced the course of the accident. Steam under pressure in the rods caused the initial rupturing of the outer sheaths. There appeared to be considerable chemical reaction, and not just melting of the materials present. It cannot be decided whether or not the exothermic aluminum water reaction played a significant role. From the analysis, it seems unlikely.
