# Pumps, instrument tubing main trouble spots in NPD startup.

The diagram below shows the eleven steps to full-power operation of NPD, whose smooth run-up has attracted wide favorable comment. They were described to the Eighth Atomic Power Symposium by L. G. McConnell of Ontario Hydro. The presentation also frankly detailed the difficulties which had been experienced due to defects in equipment, design and operating methods.\*

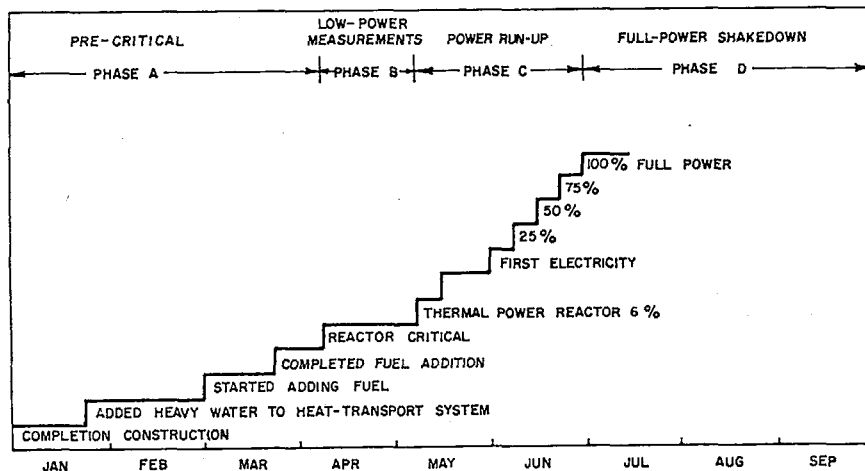
As the diagram indicates, commissioning was divided into four phases. Little difficulty was encountered in
