Chernobyl –
A Canadian Perspective

by
Dr. V.G. Snell and J.Q. Howieson

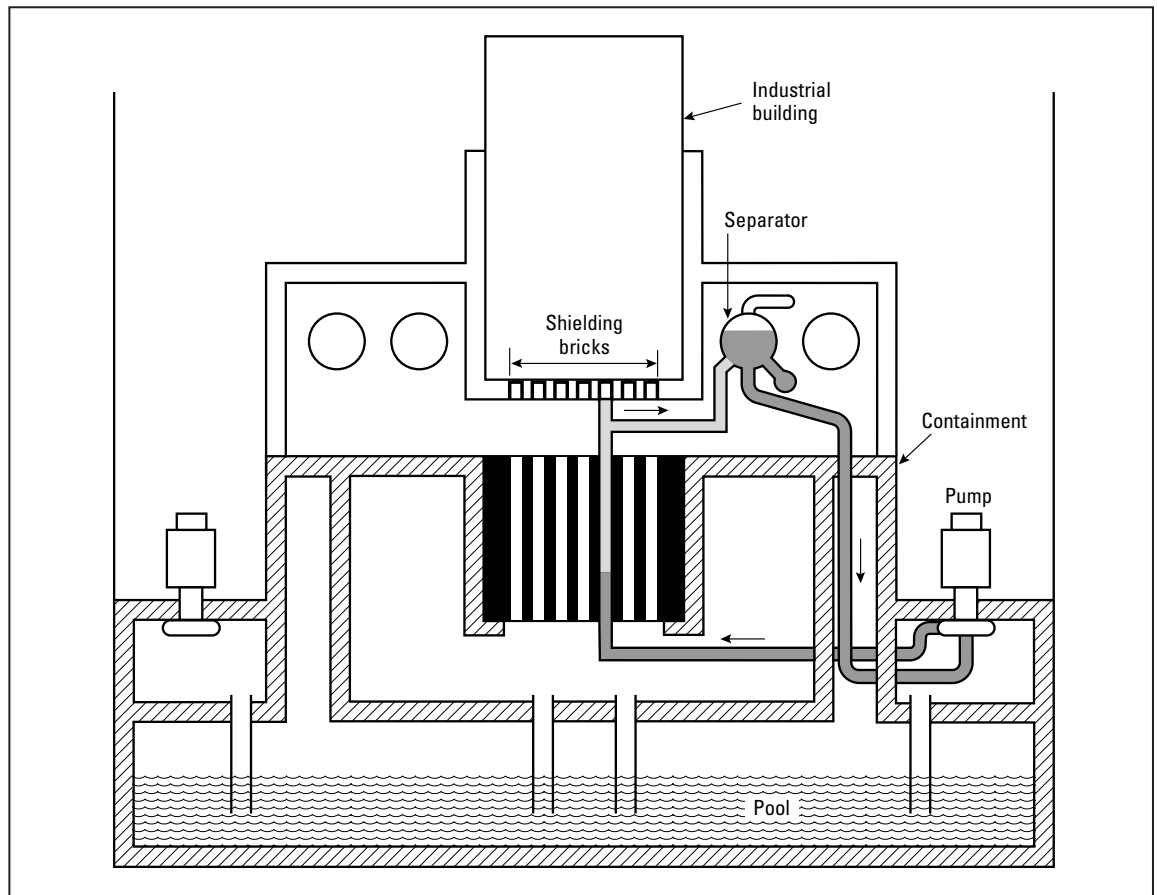
**Figure 7
Chernobyl containment**

The Chernobyl unit 4 reactor had shutdown and emergency core cooling, as we shall discuss later, but had only a **partial** containment. The pipes *below* the reactor core were inside what the Soviets called "leak-tight boxes". These boxes were connected to a huge pool of water under the whole building — the "bubbler" pond, as the Soviets named it. If one of the pipes in the boxes broke, the steam would be forced into the pond, where it and any radioactive particles it contained would be trapped in the water, and the leak-tight boxes would hold. But all the steam pipes **above** the core were inside *ordinary industrial* buildings (Figure 7). Thus if one of these pipes broke, particularly if the break were large, a release of radioactive steam would occur. The amount of radioactivity released would depend on how effective the other systems — shutdown and emergency cooling — were in preventing damage to the fuel. At first this seems hard to

We have already mentioned that Chernobyl had a partial containment. The accident bypassed this partial containment, with the releases all going out through the burst-open top of the reactor core into the region of the building where there were *no* leak-tight boxes.

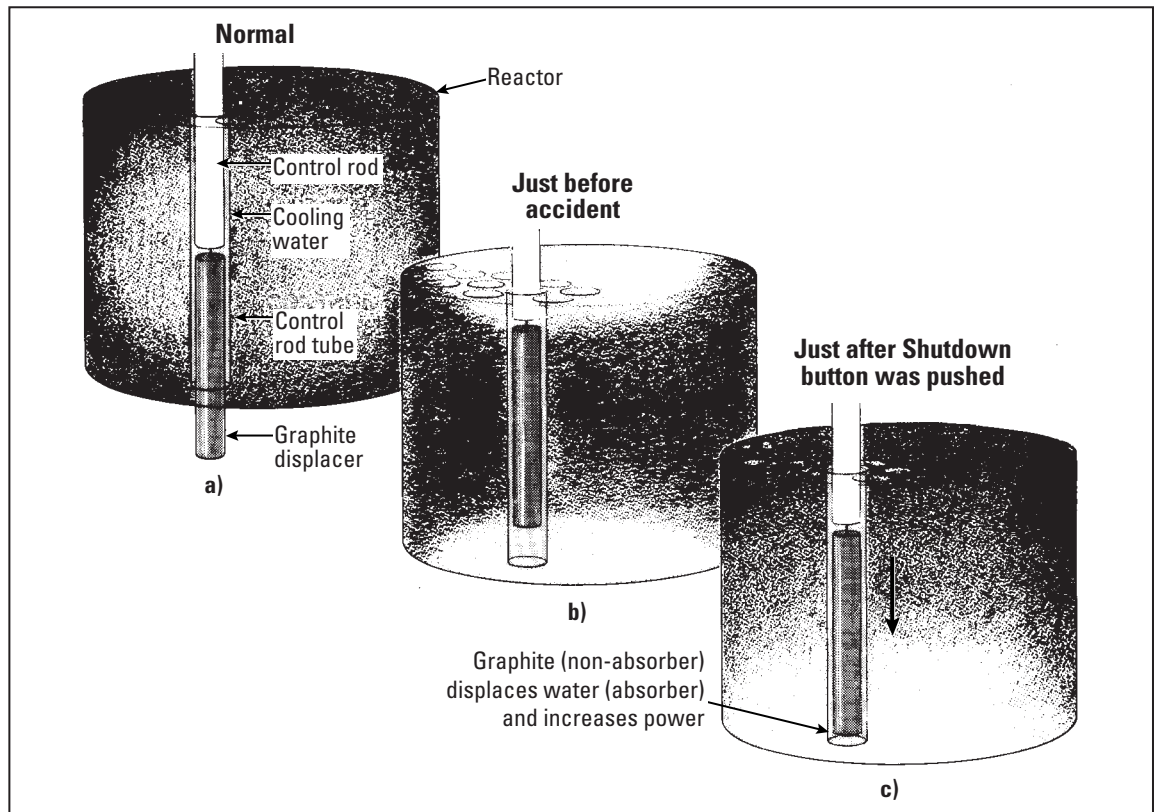
Figure 8
Role of shutdown rods

The Canadian/EPRI analysis in fact points to a more fundamental weakness in the shutdown system design. The control rods (which are also used for shutdown) travel in vertical tubes, and are cooled by flowing water. Normally the control rod moves in and out of the reactor to control the power — moving in (adding more neutron absorber) to reduce power and out to increase it. So as the control rod moved in, it would replace the water, and as it moved out, it would be replaced by water. The trouble with this scheme is that water **also** absorbs neutrons, so the effect of moving the rod would be small. To enhance its effect, at the bottom end of most of the rods, there is attached **another** rod, made of graphite — called a displacer. Graphite as we have said does **not** absorb neutrons very well. So

now when a control rod moves in, it replaces not water but graphite — so its effect on the number of neutrons is larger. And similarly when it moves out (Fig. (8a)).

So far so good. The weakness lay in the way this scheme worked if the reactor was **not** operating normally. Just before the accident, most of the control rods were pulled out of the reactor, so far out in fact that even the graphite section was **above** the bottom part of the reactor — the control rod tubes at the bottom contained only water (Fig. (8b)). Even this would not normally matter, because very little power is usually generated at the bottom. But Canadian simulations and the pattern of damage to the reactor suggest that just before the accident, most of the reactor power *was* being generated near the bottom. If the control/shutoff rods were then driven slowly in, the **first** effect would be to replace water (which absorbs neutrons) by graphite (which does not) (Fig. (8c)).

In other words, driving in the control/shutoff rods, which was supposed to shut down the reactor, would have precisely the *opposite* effect — it would cause a fast power **increase** instead. With this in mind, let us return to the sequence of events.

2. On the hardware side, in the short term the Soviets first mechanically prevented control rods from being withdrawn too far in the RBMK reactors. This caused a misshapen power distribution so the reactors had to be run at reduced power. They are now redesigning the rods so that the graphite cannot be lifted above the bottom of the core even if control rods are fully withdrawn. They also required more rods to be inserted — in fact, the plants will now shut down automatically if the operator tries to pull out too many rods. The motors of the shutoff rods have been changed to speed up shutdown — from 20 seconds to 10 (compared to 2 seconds in CANDU). A new fast shutdown design is being developed. Finally the composition of the fuel is being changed (more enrichment). These changes reduce the **size** of the positive void coefficient, and increase the effectiveness of the emergency shutdown.

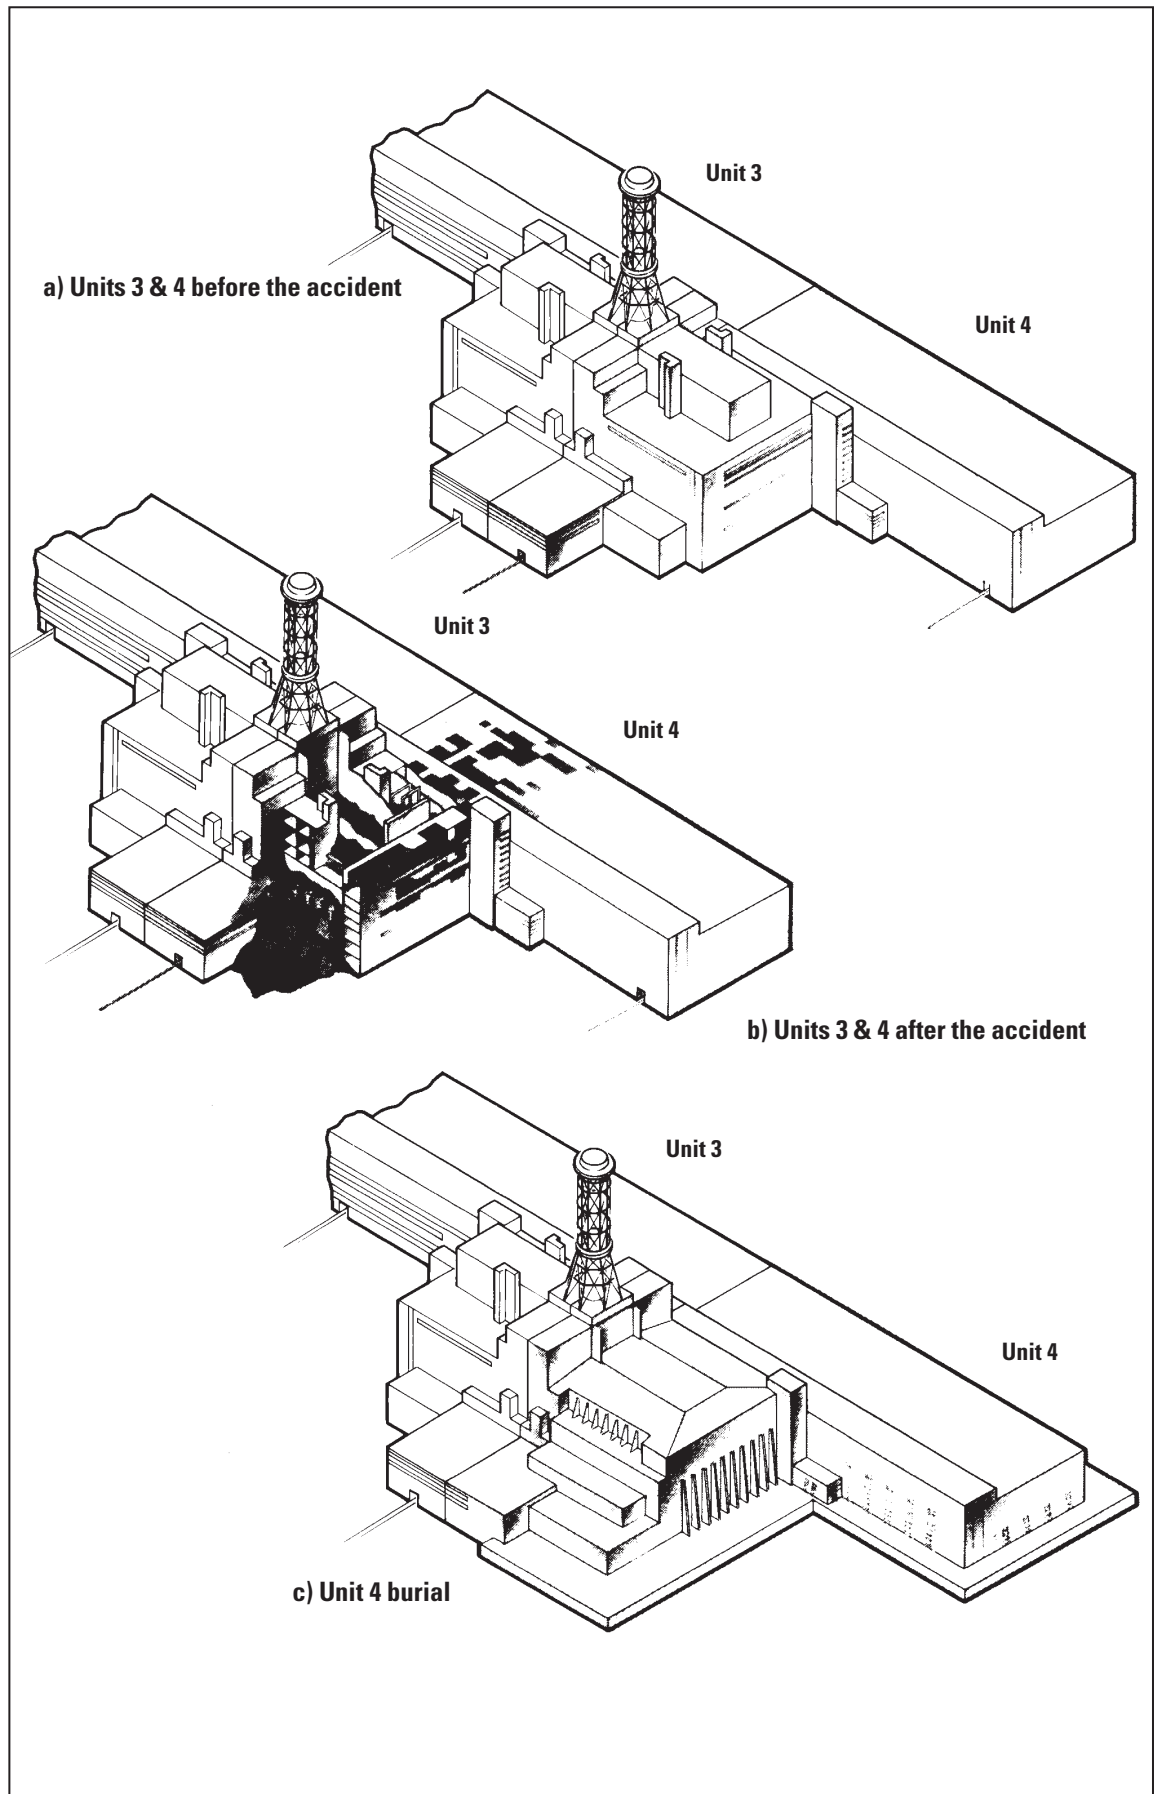
**Figure 9
Damage from the
accident**

The power surge destroyed the top half of the reactor core, the building immediately above the reactor, and some of the walls on either side (Figure 9(b)). The Soviets commented somewhat ironically that the leak-tight compartments below the reactor survived intact.

Burning fragments of fuel and graphite were thrown out in the explosion, and landed on the roof of the adjacent turbine building, causing about 30 fires on the asphalt roof and elsewhere. The Soviets' first priority was to put these out, so the damage would not spread to the reactors operating nearby. Local firefighters had extinguished all fires by 5 in the morning, but at a terrible personal cost: many of them were overexposed to radiation and were among the early casualties.

The destruction was not, of course, caused by a nuclear explosion but by steam and perhaps chemical explosions, so the damage was confined to unit 4. Indeed, unit 3 was kept generating electricity for several hours, and the other units for somewhat longer, until they were all shut down in a controlled manner because of the increasing radioactive contamination of the area.
